# Manhole Inspection Summary

Manhole # S31A\_\_026MH

Insp Date: **10/16/07 3:15 PM**

**Location** Address: **558 ORCHARD ST**

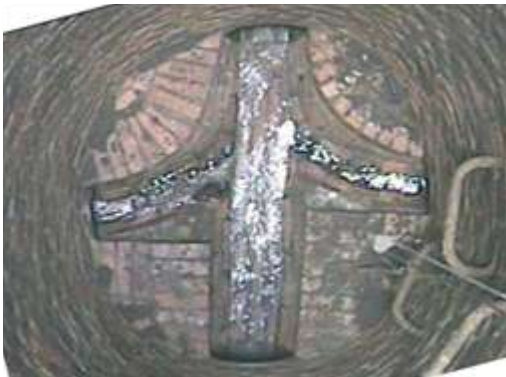
Top View

Condition: ☐ Sound ☒ **Cracked** ☐ Leaks

☒ **Evidence Of Surcharge** Depth: **3** (ft.) ☐ Active Surcharge Present

frame cracked and evidence surcharge

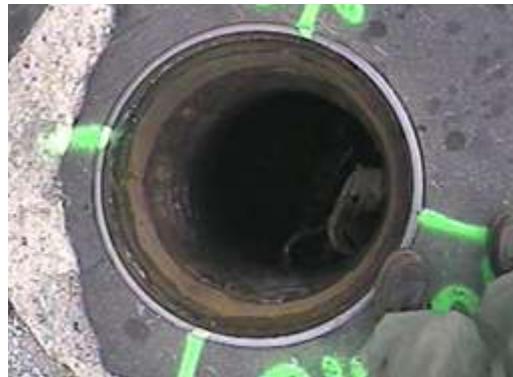
Defect 1

frame cracked and evidence surcharge

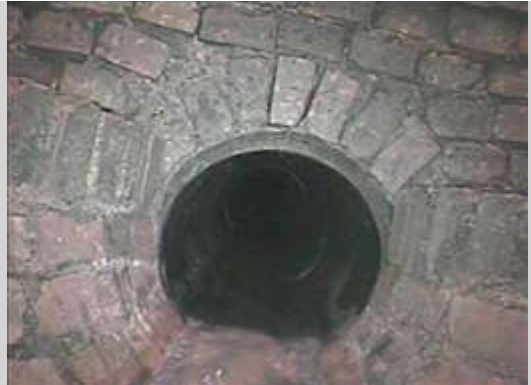
12 O'Clock Outflow

12 in. Circular Gravity Sewer  
Pipe Out @ 12 O'Clock

Pipe Height: (in.) Direct  
Pipe Material: **Clay** ☐ Pipe Lined  
Invert Depth: **13.29** (ft.) Flow Characteristics: **Fast**  
Deposits: ☒ None ☐ Mud ☐ Sludge ☐ Debris ☐ Grease  
Silt Depth: (in.) Deposits Extent:  
Infiltration: **None** Pipe Seal Cond: **Sound**

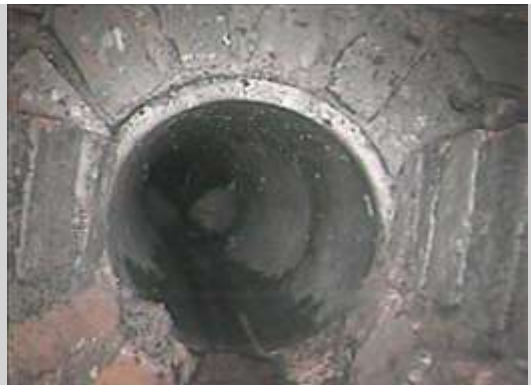
3 O'Clock Inflow

8 in. Circular Gravity Sewer  
Pipe In @ 3 O'Clock

Pipe Height: (in.) Direct  
Pipe Material: **Clay** ☐ Pipe Lined  
Invert Depth: **12.94** (ft.) Flow Characteristics: **Slow**  
Deposits: ☒ None ☐ Mud ☐ Sludge ☐ Debris ☐ Grease  
Silt Depth: (in.) Deposits Extent:  
Infiltration: **None** Pipe Seal Cond: **Sound**

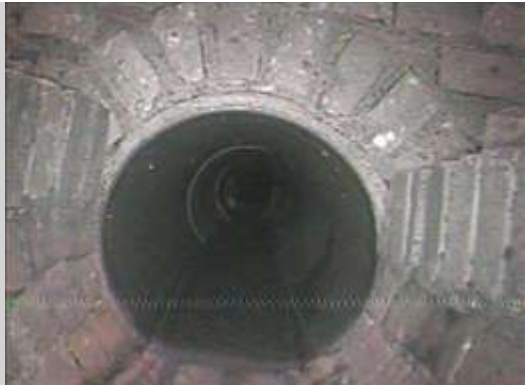
6 O'Clock Inflow

12 in. Circular Gravity Sewer

Pipe In @ 6 O'Clock

Invert Depth: **13.25** (ft.) Flow Characteristics: **Slow**

Infiltration: **None** Pipe Seal Cond: **Sound**

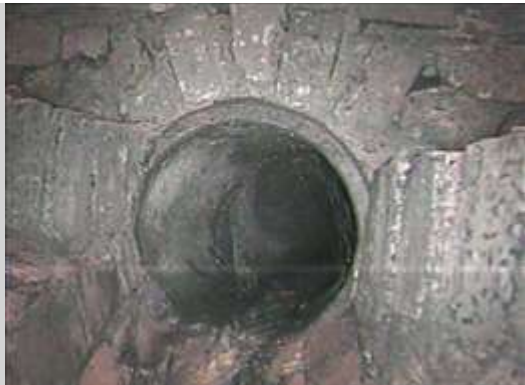
9 O'Clock Inflow

8 in. Circular Gravity Sewer

Pipe In @ 9 O'Clock

Invert Depth: **12.98** (ft.) Flow Characteristics: **Slow**

Infiltration: **None** Pipe Seal Cond: **Sound**
